LOWER LAKE DAM

NDI - PA 00306

PHASE I INSPECTION REPORT NATIONAL DAM INSPECTION PROGRAM

MAY 1979

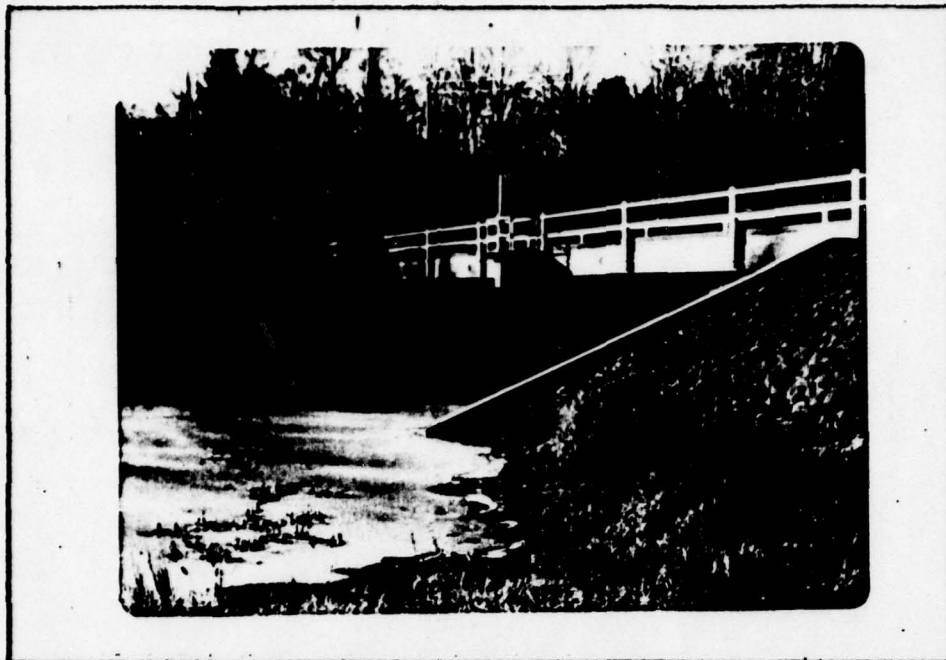
**THE UPSTREAM SIDE OF THE DAM SHOWING THE
SPILLWAY STRUCTURE, BRIDGE, AND THE EMBANKMENT**

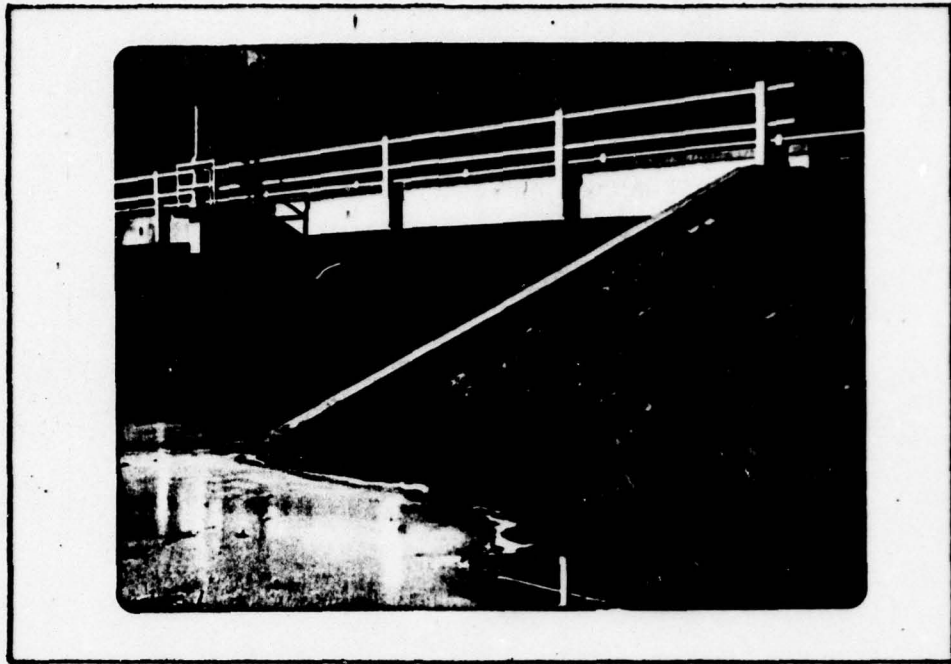
- a. Visual Observations. Riprap facing on the upstream slope of the embankment is missing or covered by grass and earth. Minor settlement of up to 3 inches of the embankment adjacent to the downstream right wingwall tie-in could be due to poor compaction of earth adjacent to wingwall.

**VIEW OF THE UPSTREAM SLOPE OF THE RIGHT
ABUTMENT SHOWING EROSION ALONG THE WINGWALL**

1. Eroded areas on the upstream face of the embankment should be filled; graded filter and riprap should be provided where wave protection is inadequate.
2. The area of settlement adjacent to the right wingwall on the downstream side should be excavated several feet and the backfill

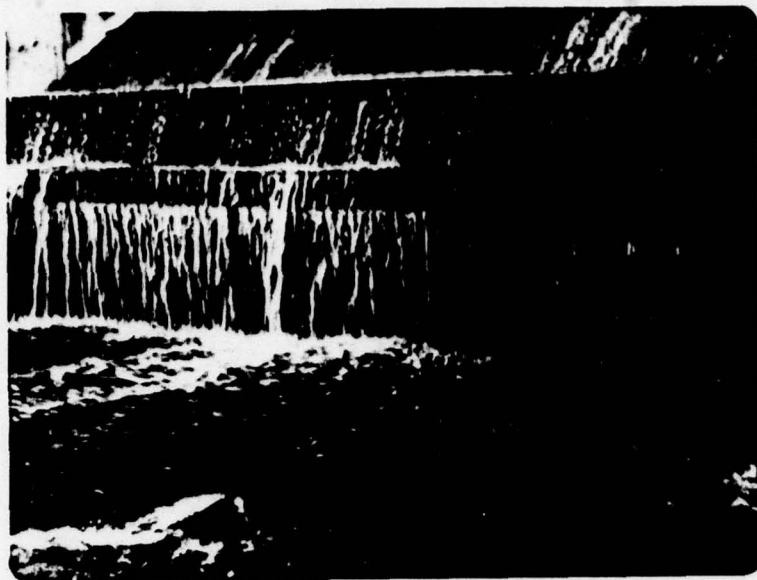
**OUTLET CONDUIT
EMBEDDED IN THE ENDSILL**

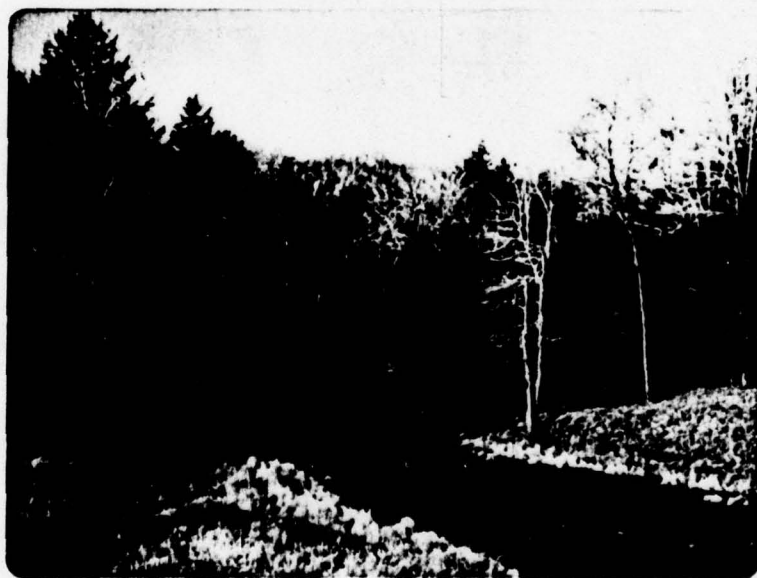
**WALLENPAUPACK CREEK
DOWNSTREAM OF THE DAM**

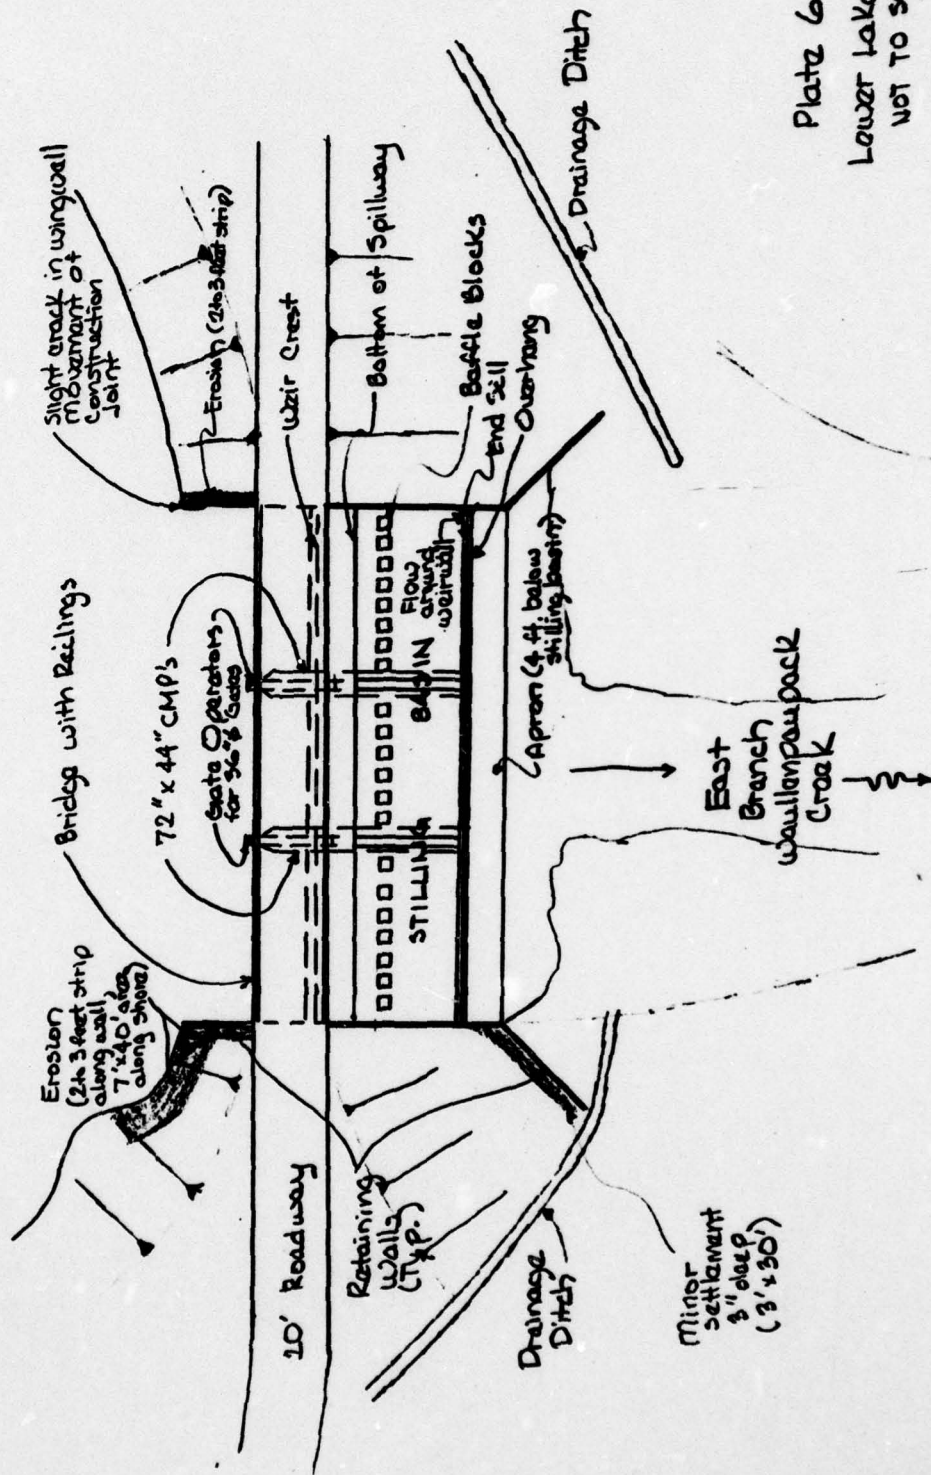
Plate 6
Lower Lake Dam
NOT TO SCALE

- b. Dam. The riprap on the upstream side of the embankment is missing or covered by grass and earth. There is an area of minor settlement of up to 3 inches in the embankment adjacent to the downstream right wingwall tie-in. This area is approximately 3 feet wide and 30 feet long. Erosion has created depressions up to 12 inches deep along both upstream wingwalls and depressions up to 3 inches deep on the lower half of the upstream slope on the right side of the embankment. The depressions along the wingwalls cover a 2 to 3 feet wide strip from the top of the dam to the waterline. The eroded area of the embankment covers a 7 foot wide strip starting at the wingwall and extending approximately 40 feet.

- c. Appurtenant Structures. A crack at the upstream end of the left wingwall at the tie-in was observed as well as a differential movement of approximately 1/4 inch of an adjacent construction joint. Occasional hairline cracking and spalling of the wingwalls were noted.
